Inspection Report

Property Address:
12345 Sample Rd
Tampa FL 33624

Stone Eagle Home Inspections, LLC

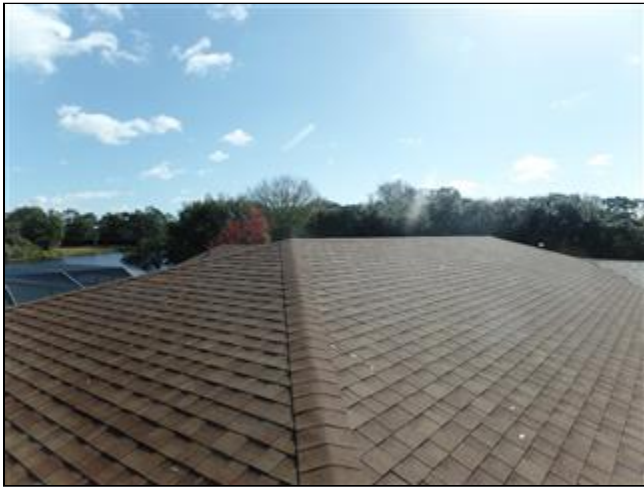
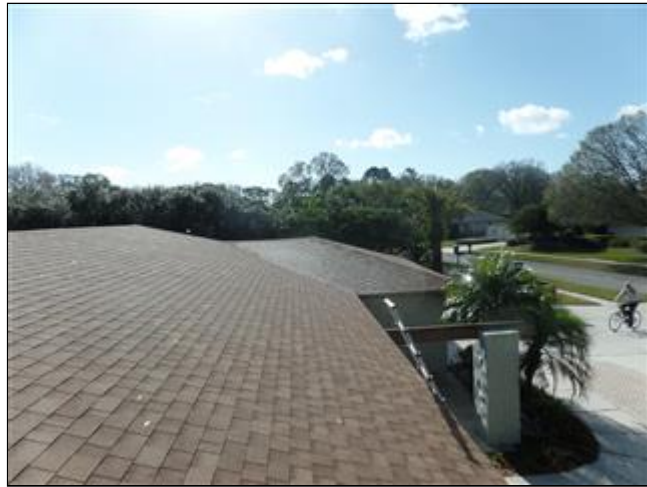
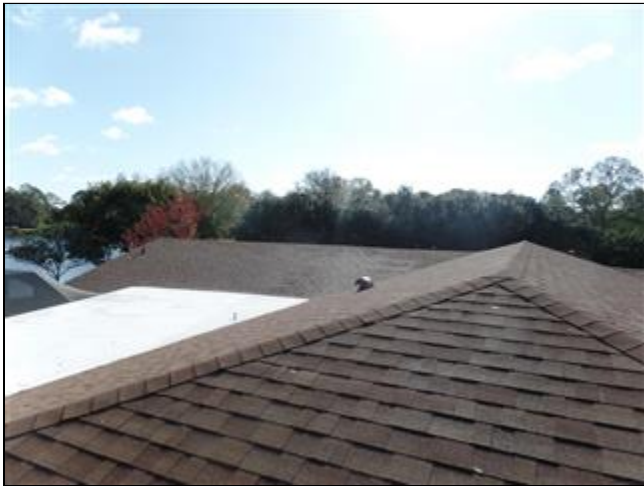
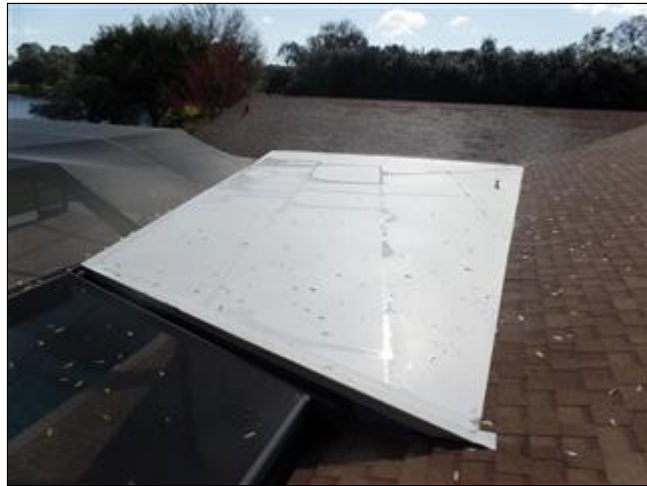
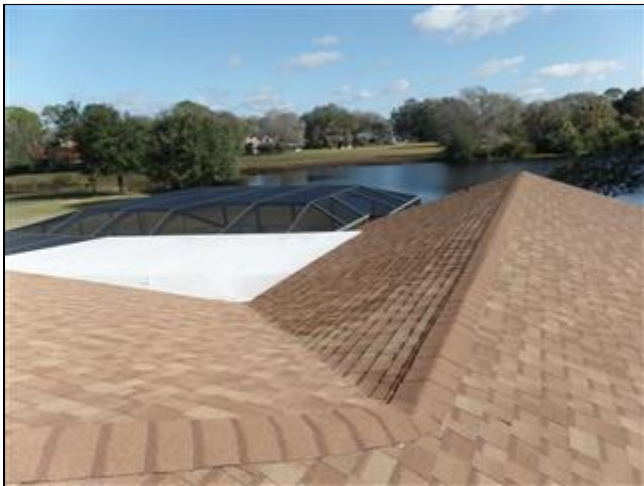
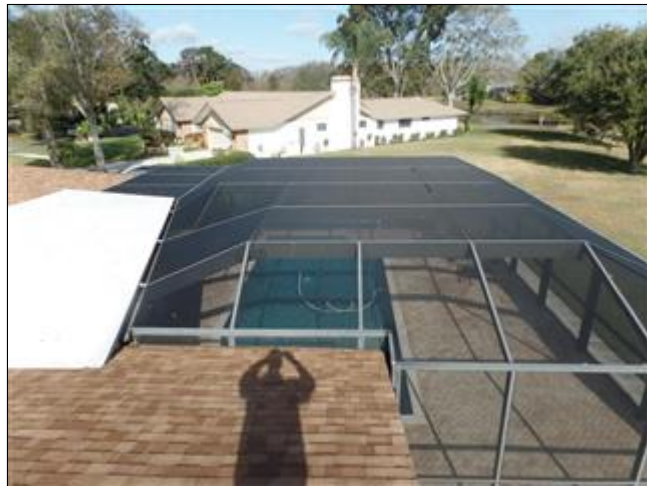
1.0 Item 1(Picture)

1.0 The roof is 1 year old. A asphalt shingle roof like this one will last 20 years.

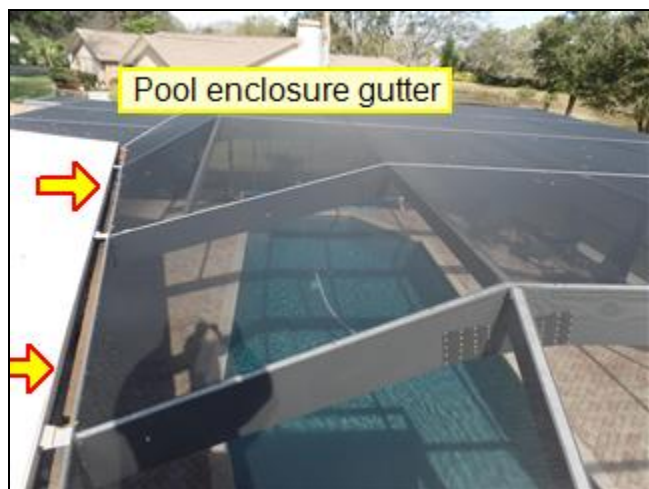
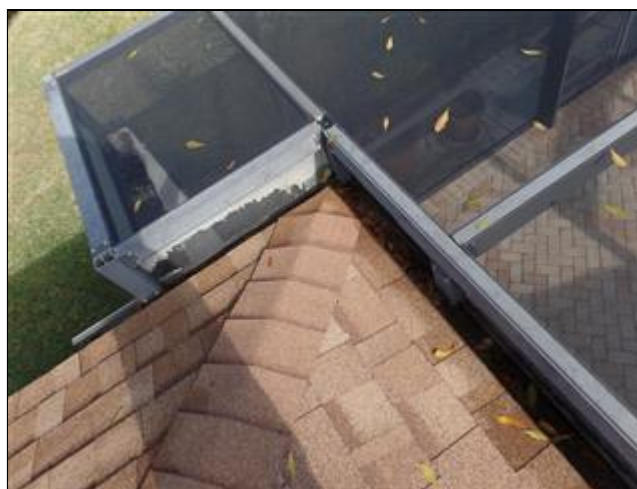
1.3 Item 1(Picture)

1.3 The roof has no gutter system except for the pool enclosure. I recommend installing a gutter and down spout system for the entire roof. Then direct the water AWAY from the house. This prevents water from getting under the slab and settling the foundation.

The roof has no gutter system except for the pool enclosure. I recommend installing a gutter and down spout system for the entire roof. Then direct the water AWAY from the house. This prevents water from getting under the slab and settling the foundation.

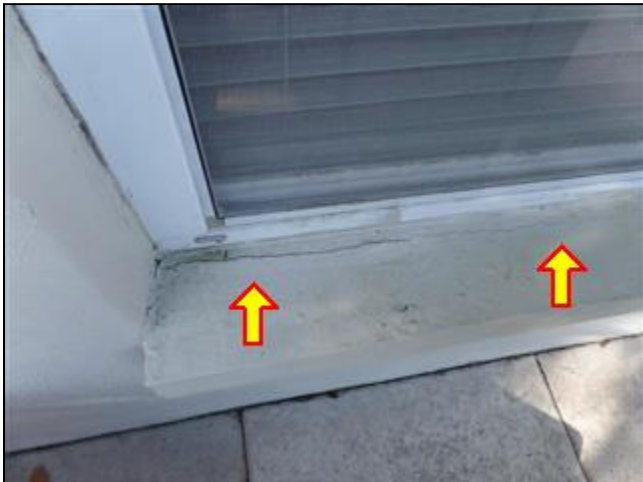
2.2 Item 1(Picture)

2.2 There are cracks in the window sill on two window, one in front and one on the right side. Seal these with calking to prevent water intrusion which will make them worse.

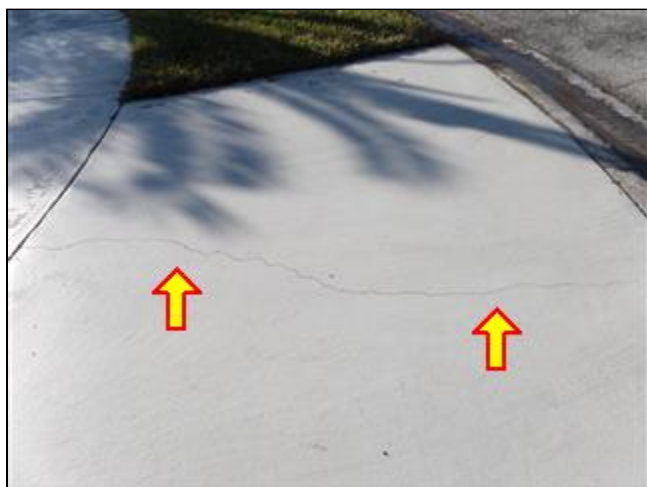
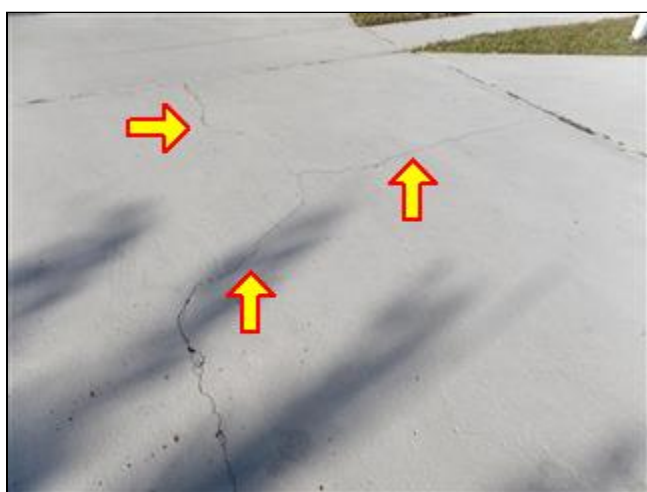
2.6 Item 1(Picture)

2.6 There are settling cracks in the driveway. This is not unusual for a home of this age. Keep the cracks sealed to prevent water intrusion.

There are settling cracks in the driveway. This is not unusual for a home of this age. Keep the cracks sealed to prevent water intrusion.

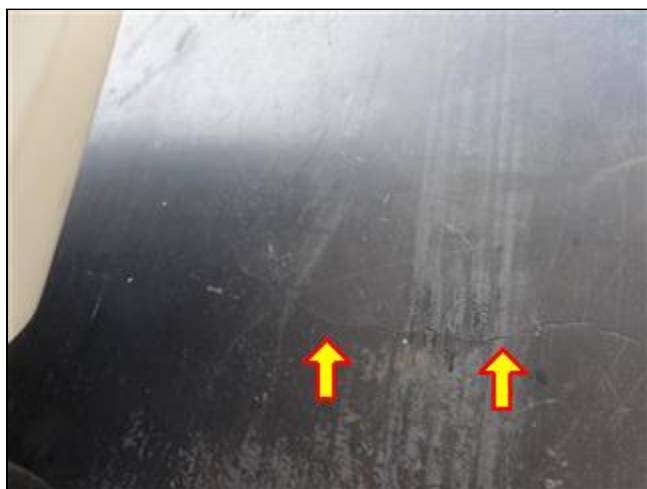
3.2 Item 1(Picture)

3.2 Normal settling cracks in the floor of the garage

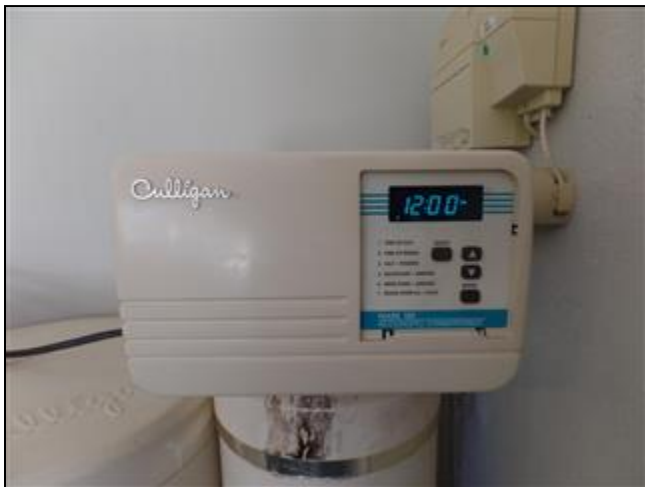
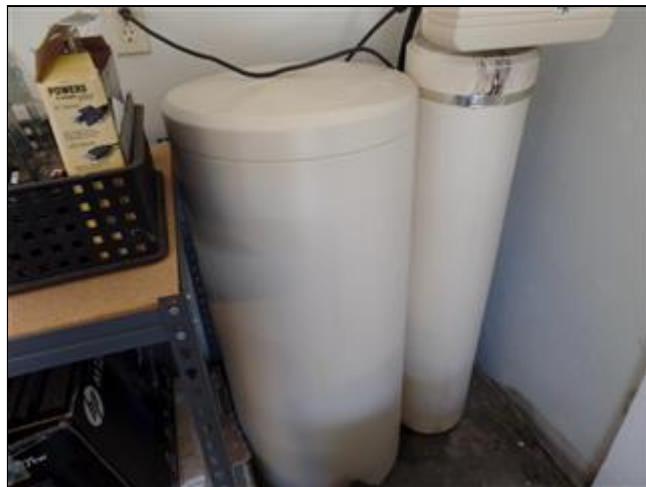
6.1 Item 1(Picture)

6.1 The home has a Culligan water treatment system that in not being used. It came on when I plugged it in. I recommend getting it serviced by a Culligan professional if you choose to use the system.

The home has a Culligan water treatment system that is not being used. It came on when I plugged it in. I recommend getting it serviced by a Culligan professional if you choose to use the system.

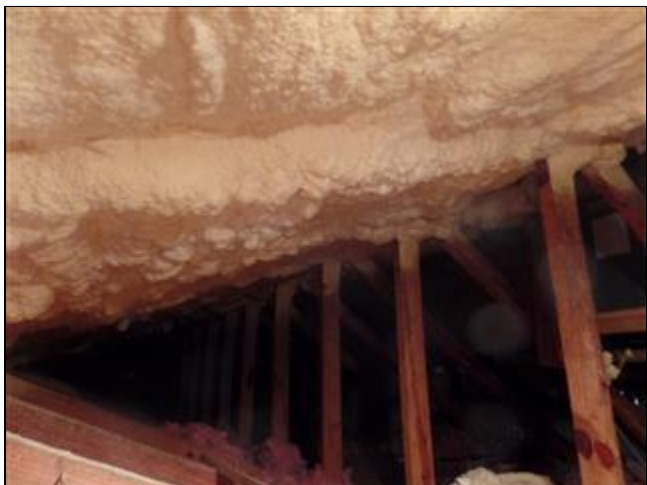
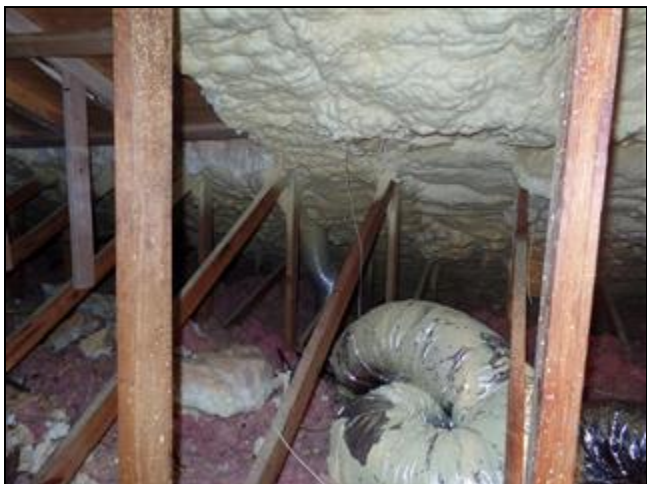
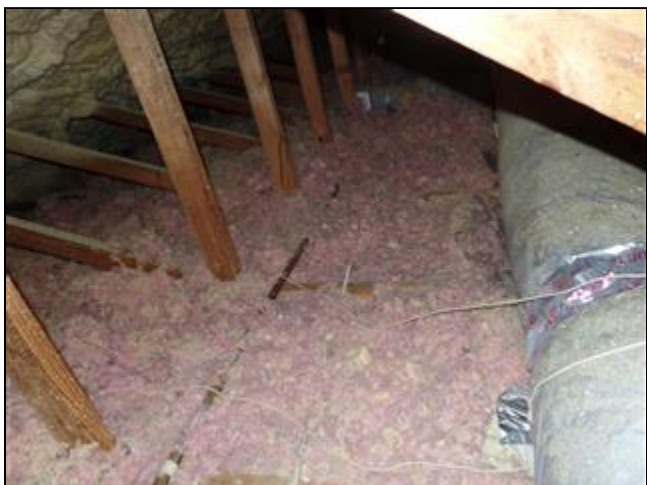
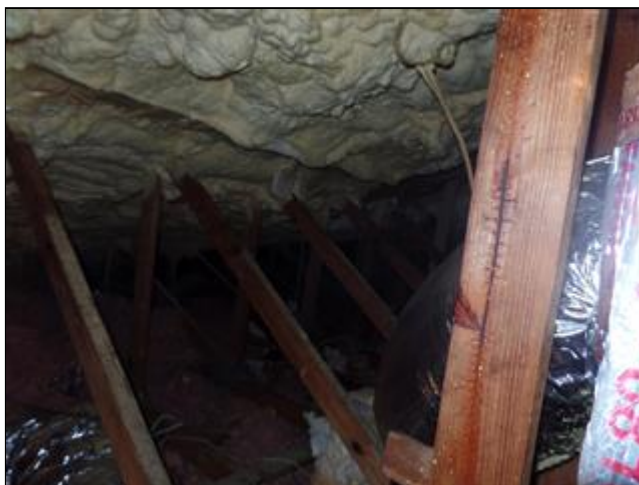
9.0 Item 1(Picture)

9.0 The attic is well insulated to include a coating of insulated foam on the ceiling of the attic. This is good and bad. It's good because it provides extra insulation. It can be bad because if water leaks from the roof into the attic it will be trapped between the sheathing and foam and will rot the plywood sheathing. This has already happened and the owners had to replace several plywood sheets when they replaced the roof.

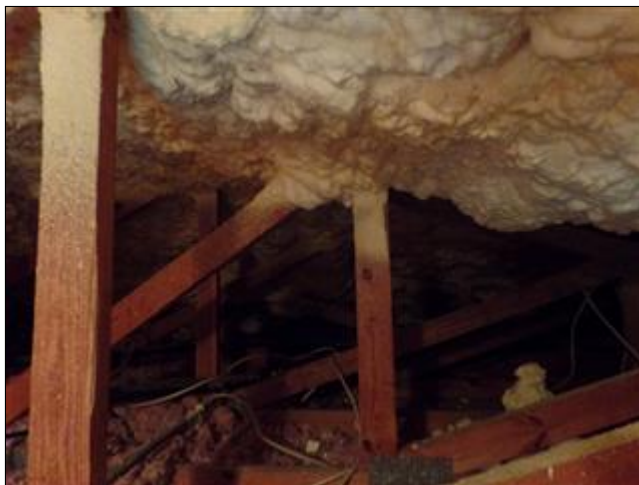
9.0 Item 2(Picture)

IN	NI	NP	RR	SA	Styles & Materials
9.0	Insulation in Attic	•					Attic Insulation: Blown Polyurethane foam R-30 or better Ventilation: None found Dryer Power Source: 220 Electric Dryer Vent: Flexible Metal Floor System Insulation: NONE
9.1	Insulation Under Floor System			•			
9.2	Vapor Retarders (in Crawlspace or basement)			•			
9.3	Ventilation of Attic and Foundation Areas	•					
9.4	Venting Systems (Kitchens, Baths and Laundry)	•					
9.5	Ventilation Fans and Thermostatic Controls in Attic	•					
9.6	Dryer Vent	•					
		IN	NI	NP	RR	SA

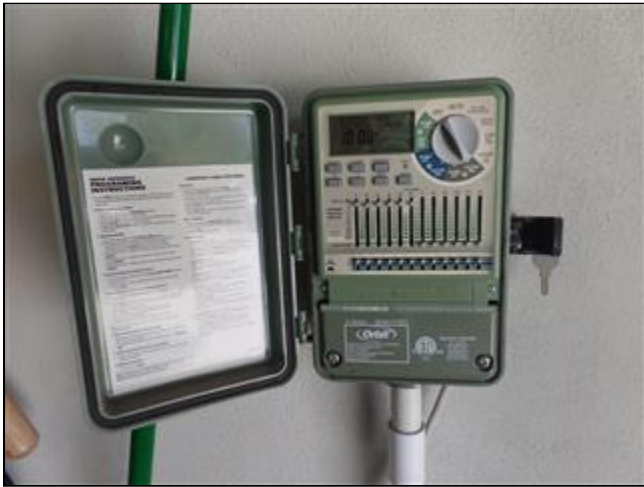
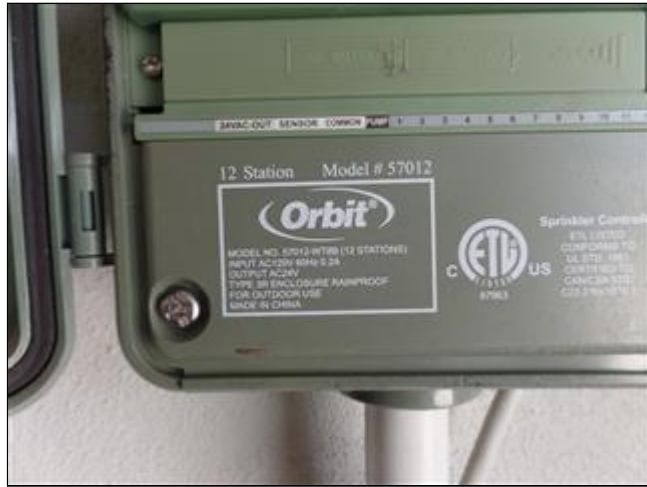
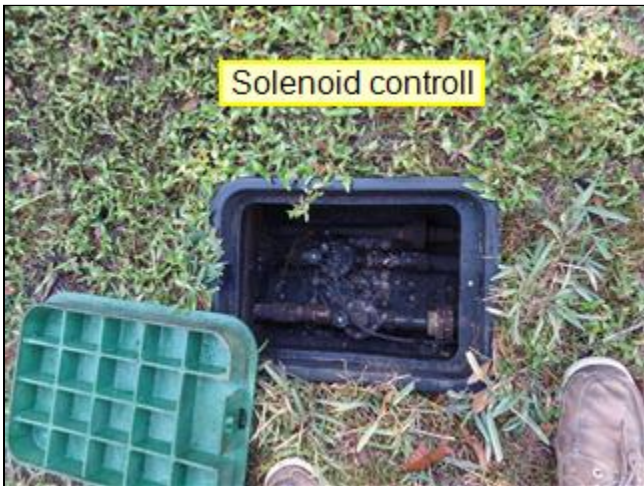
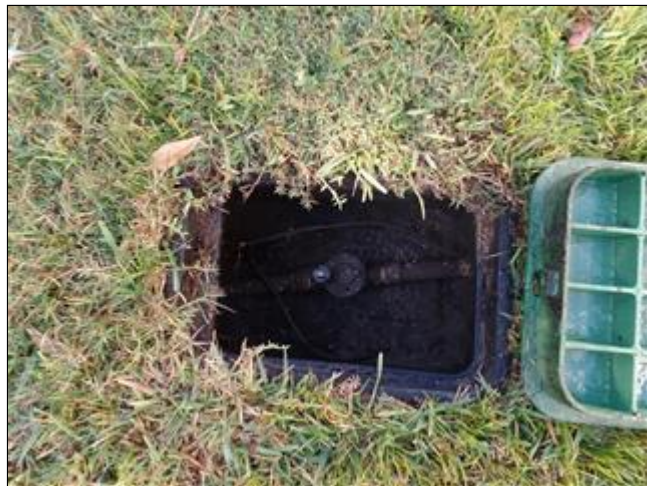
11.1 Item 1(Picture)

11.1 There are two access points for the lawn sprinkler solenoids. Both on the right hand side of the house.

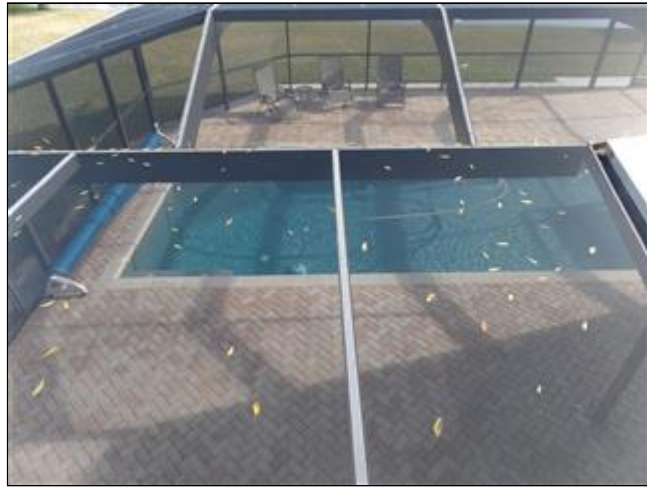
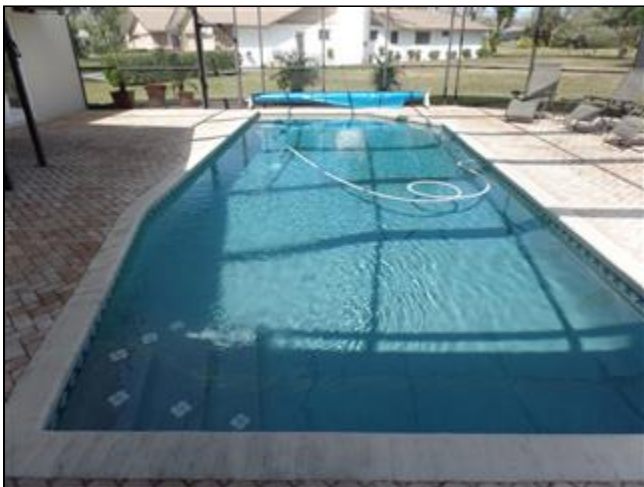
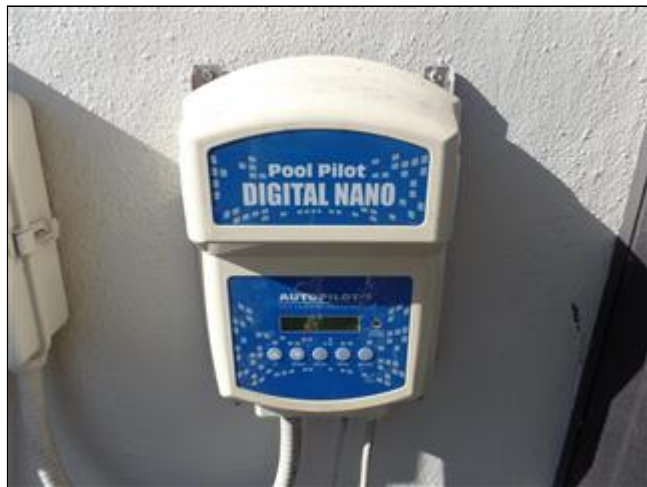
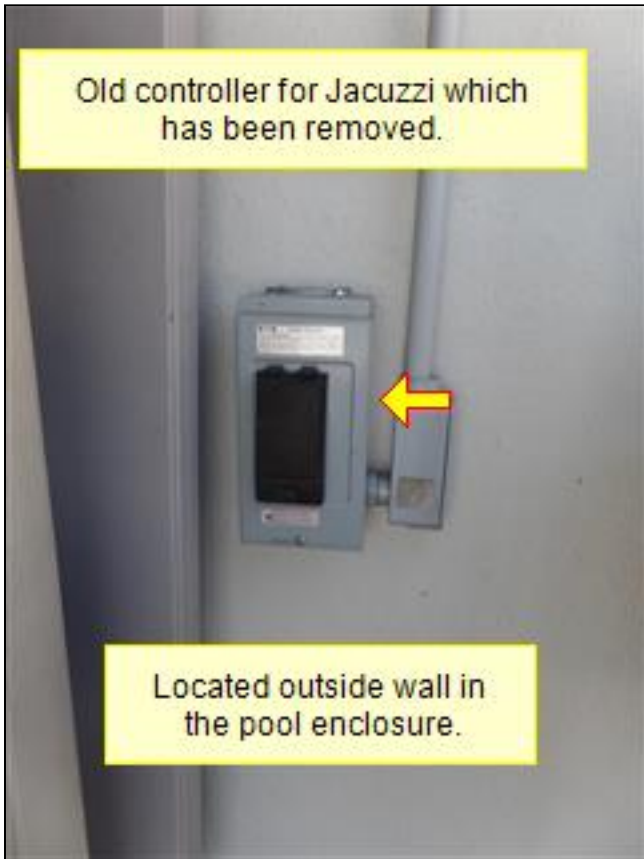
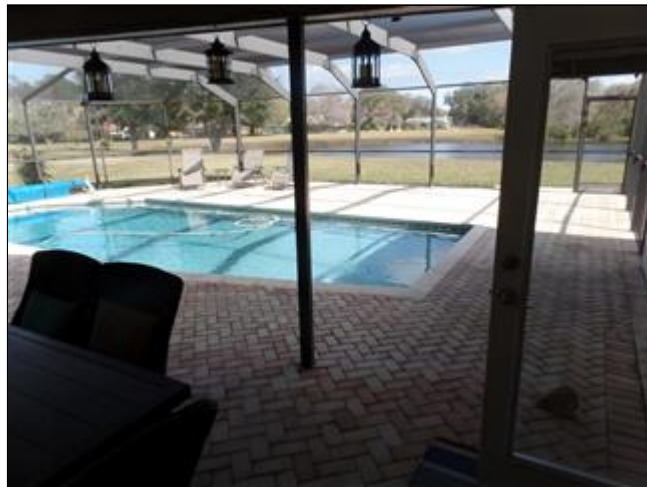
12.0 Item 1(Picture)

12.0 The pool appeared to be in excellent condition. I recommend getting the equipment serviced to establish an initial baseline.

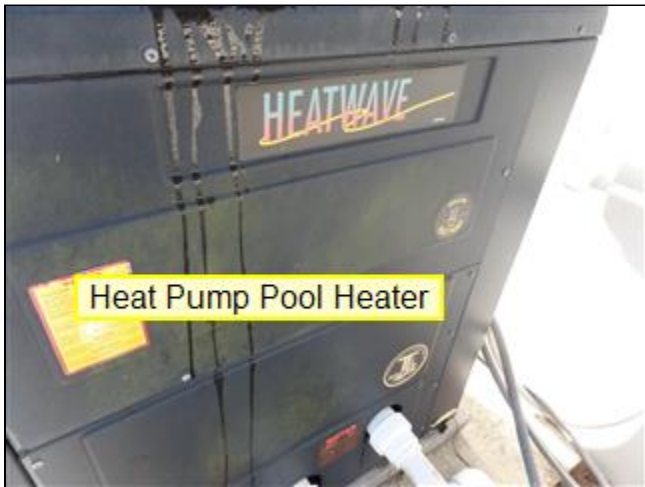
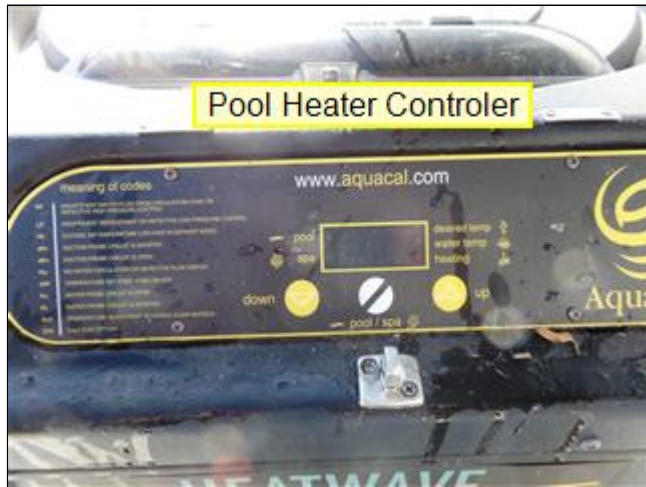
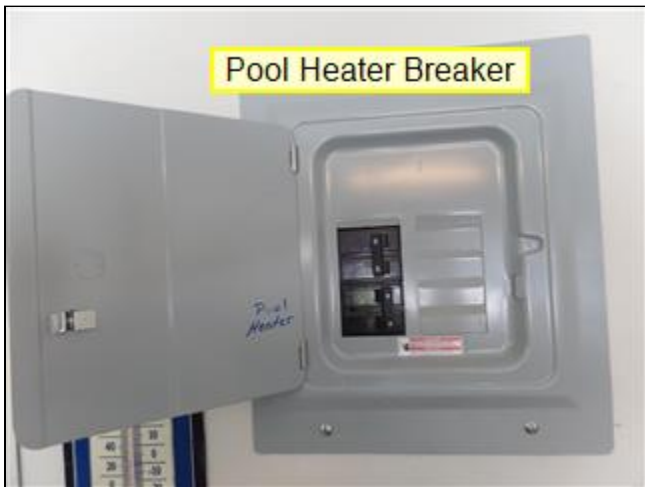
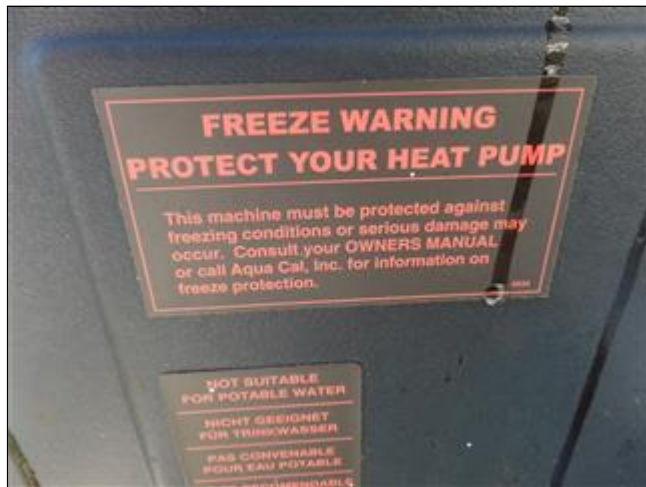
12.6 Item 1(Picture)

12.6 The pool heat source is a Heat Pump. The switch is located in the small breaker sub panel in the garage next to the main panel. I turned the heat pump on and it appeared to work. The owner reported that he never uses it and it sits idle. I recommend getting the pool heater serviced to establish a baseline.

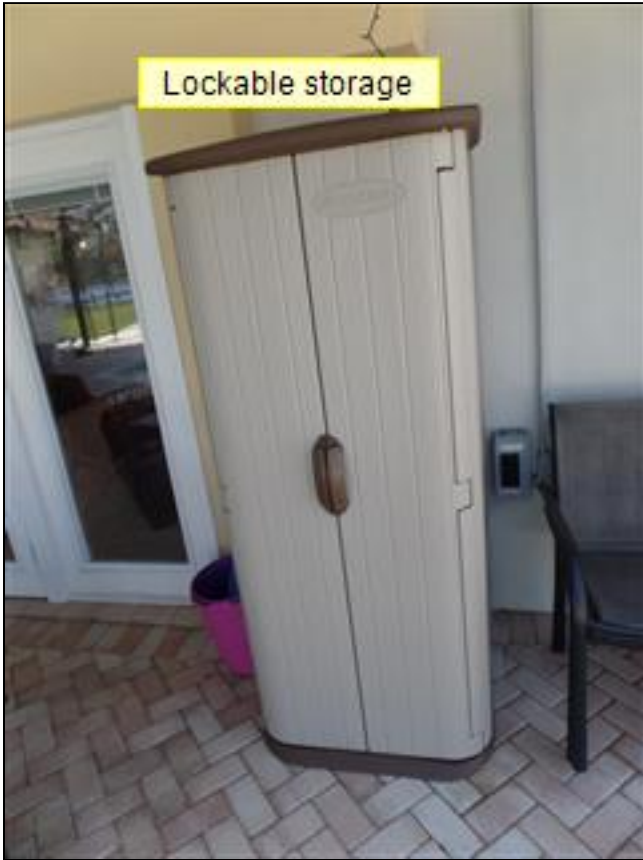
12.9 Item 1(Picture)

12.9 There is lockable storage for pool chemicals however the owners may take it with them. I recommend locking up all pool chemicals for safety.
